UPPER HUDSON RIVER WATERSHED  
SACANDAGA RIVER BASIN

**LAKE ALGONQUIN DAM**  
**HAMILTON COUNTY, NEW YORK**  
APPROVED FOR PUBLIC RELEASE;  
DISTRIBUTION UNLIMITED  
CONTRACT NO. DACW 51-78-C-0035

**PHASE I INSPECTION REPORT**  
**NATIONAL DAM SAFETY PROGRAM**

Prepared by  
CONVERSE WARD DAVIS DIXON  
CONSULTING ENGINEERS  
91 ROSELAND AVENUE, P.O. BOX 91  
CALDWELL, NEW JERSEY 07006

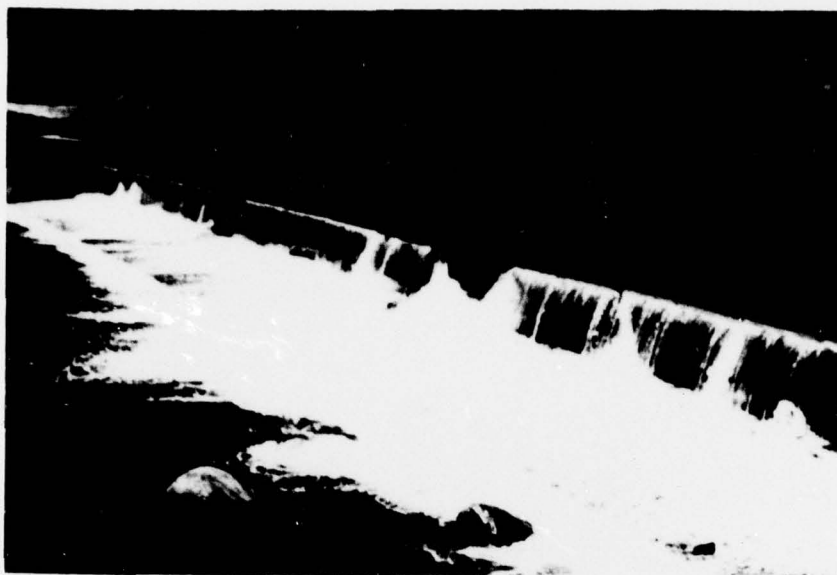
FIGURE 18 DOWNSTREAM CHANNEL

The downstream channel is about 300 feet wide and contains many large boulders (Fig. 18, Appendix D). There is a rock formation approximately 100 feet downstream in the center of the Riverbed that is apparently a bedrock outcrop. The State Highway 30 bridge crosses the channel about 500 feet downstream of the dam, and does not appear to be a serious constriction. It was observed, however, that the upstream wingwall of the right abutment of this bridge was displaced laterally upstream by about 5 inches along a large vertical crack near its center.
